Case Study: Cooling Tower Rehab

Kansas State University Vet Med Center

Project Brief: Comprehensive Refurbishment and Relining for 6-Cell 31,200-MBH Cooling Tower, allowing expansion of chiller plant capacity.

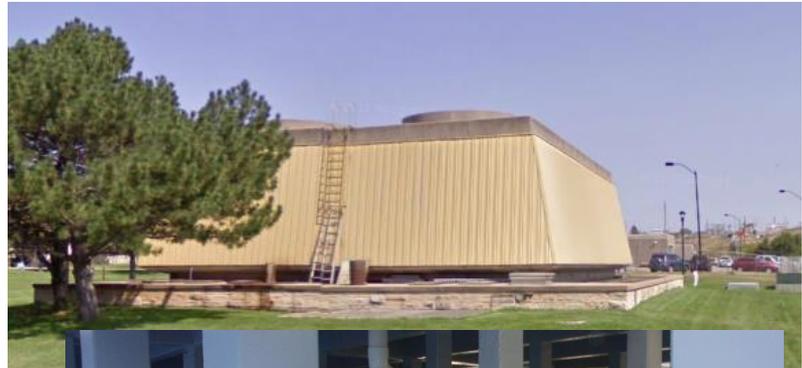
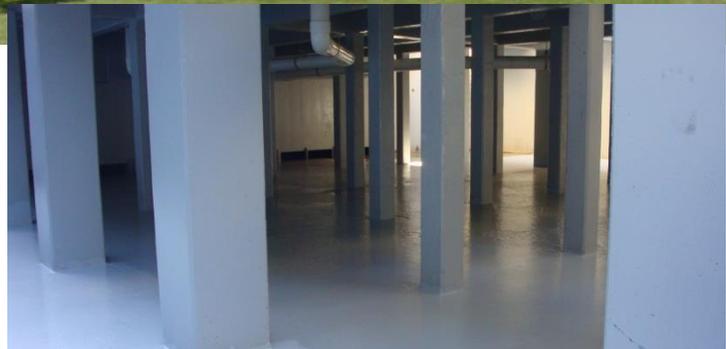
This six-cell 50'x30'x30' tower is located immediately on the campus, and due to its condition was in need of a rehab and life extension for a concurrent chiller plant capacity upgrade. All internal components of the tower were not previously coated. Photo documentation shows the concrete basin, and distribution system had significant deterioration, scaling and corrosion. Furthermore, the fill was significantly scaled and worn.

At water level, large areas of the original internal concrete were delaminated and could be removed by hand with minimal effort, which would have only been accelerated by power washer cleaning. Continual ingress of water beneath the concrete endangered the structural wellbeing of the concrete substrate with continued corrosion, and also risked the growth of micro aquatic bacteria including Legionella, Pseudomonas and Biofilm. If left untreated, this situation would lead to further deterioration in the tower surface structure as well as potential contamination of the supply with unhygienic and potentially harmful water. Our goal, besides increasing system capacity and extending the life of the cooling tower was to enhance the cleanliness of the system and the water in it, and avoid the use of materials that harbor bacteria and other micro-organisms or provide nutrients for microbial growth.

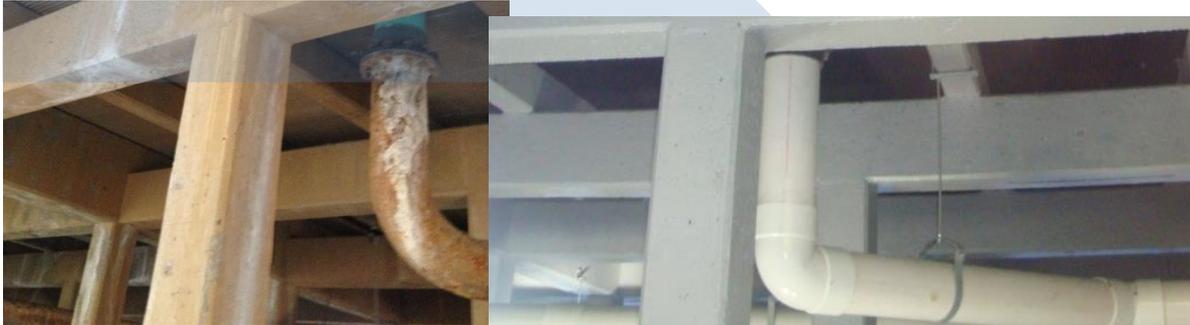
DISTRIBUTION SYSTEM

The existing distribution system piping comprised of schedule 40 steel and was seriously corroded. New schedule 40 PVC was used for headers and lateral distribution. ABS nozzles were installed for optimal flow and dispersion of spray system.

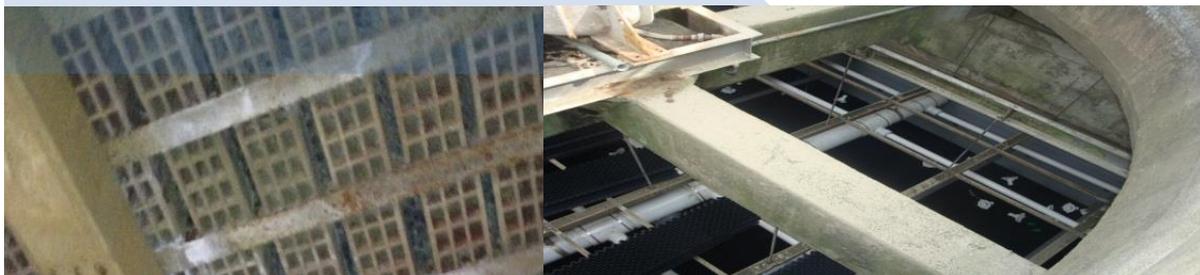
FILL REPLACEMENT

Existing fill was replaced with new PVC fill:15 mil after forming (Brentwood OF21ma-15). Drift eliminators were replaced with PVC Cellular 20 mil. FRP structural shapes were used for fill and drift eliminator support.

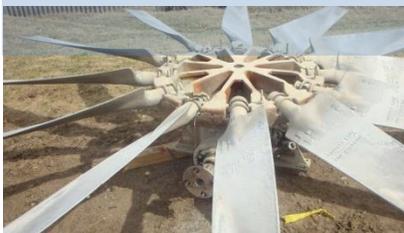
FANS

Four existing fans were replaced with FRP blades, HDG Hubs, Ductile Iron Hub Spools, and Aluminum Blade Clamps.
