Cooling Tower Restored for 80% Less Than the Cost of Replacement

Cherry Tower

Return full functionality to rooftop BAC cooling tower

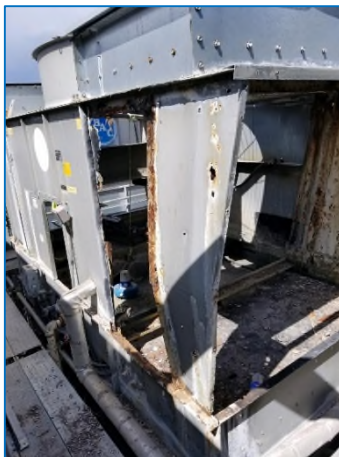
Before

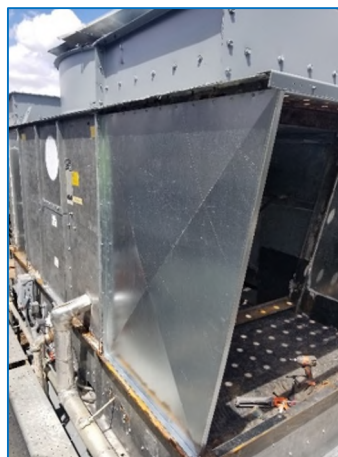
After Sheet Metal Repair

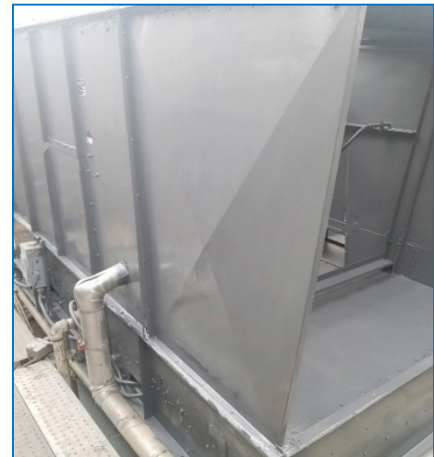
After Coating
