“It Looked like scrap metal before HVAC Armor CT brought it back to life!”

The Meadowlands Hilton had an abandoned 300-ton Baltimore Aircoil Cooling Tower on the roof. This unit had been out of commission since before current facilities staff were hired.

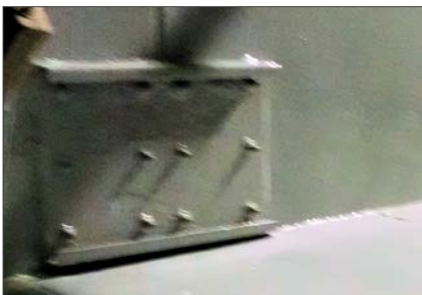
After

Over the course of five days, the rust was removed, the CT was patched and repaired, and finally it was covered with HVAC Armor CT coating. Ready for re-commissioning.

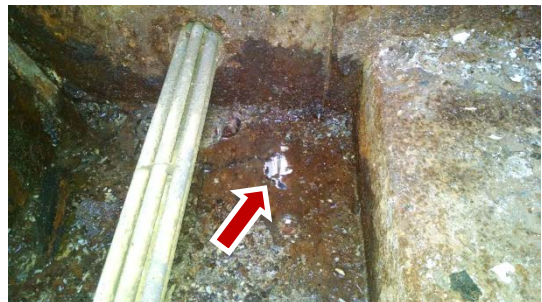
The basin had 3” holes

While most of the system was salvageable, HVAC Armor removed a basin, heaters, fill, and float.
