Refurbish and Reinsulate Basement Air Handling Unit

Oshkosh Corp.

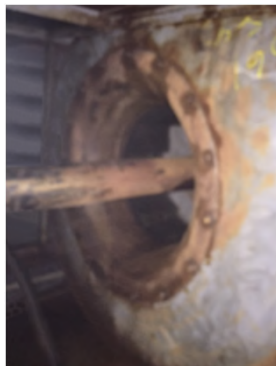
Before

The air handling unit for the executive office building was slowly failing. The unit was rusting and collecting contaminants, while saturated insulation fell away from walls and other surfaces.

Our HVAC Armor team cleaned both interior and exterior, removing all insulation in the process.

We repaired damaged areas and replaced the fan belt, then ground the walls and bottoms of the AHU to remove corrosion. That was followed by coating interior and exterior surfaces, with a special coating for the evaporator coil.
