Pepsi Rolled-out HVAC Armor Coating Nationwide

Problem: HVAC Efficiency Decline

Solution: 7-Step Rejuvenation Process

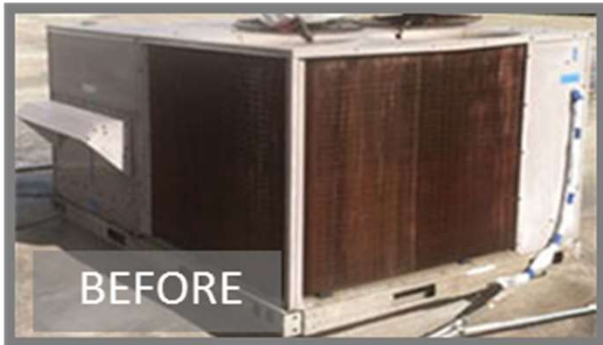
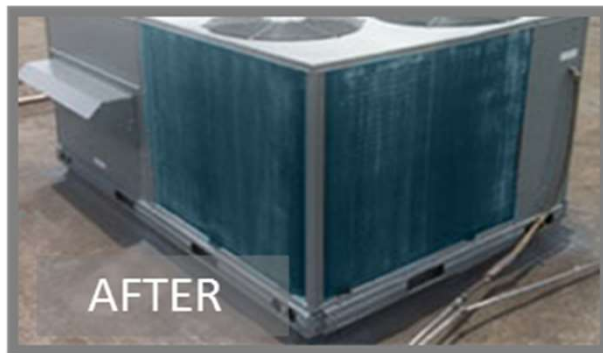
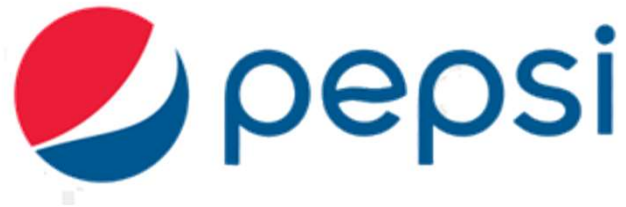
Houston's atmosphere provides one of the most corrosive environments to coils and fins of rooftop HVAC units. Pepsi's Sustainability group contacted with HVAC Armor to rejuvenate the existing condensing coils, as well as increase the performance of the HVAC units at the Bottling Plant. The HVAC Armor Coil Coating was chosen to recover the condenser's heat transfer capability to the original state.

In an effort to rejuvenate the equipment, HVAC Armor was applied to the entire coil and cabinet surfaces. The aluminum impregnated coating restored deteriorated aluminum, greatly improving heat transfer. The UV resistant and hydrophobic properties of the coating further prevent corrosion, the build-up of dust and mold - allowing for easy cleaning.

The condensers performance is evaluated pre and post renovation. An ammeter is used to measure the current drawn from the condenser. Temperature recorders are used on both sides of the cooling coils to record the difference in temperature. The condenser Coefficient of Performance (COP) is calculated from the power drawn and heat transfer. Results show an increase in COP by 12.8%.

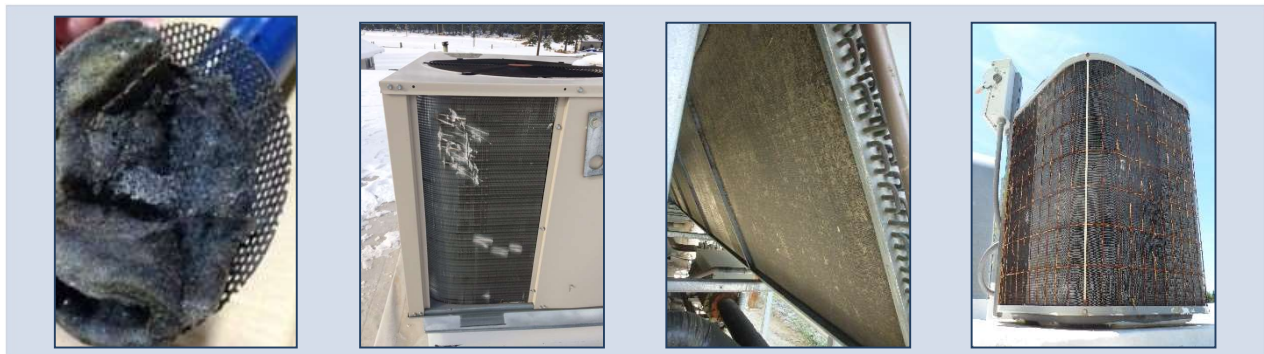
Three Types of Refrigerant System Deterioration:
