Cooling Tower Basin Cleaned, Repaired, & Coated

UMass Memorial Medical Center

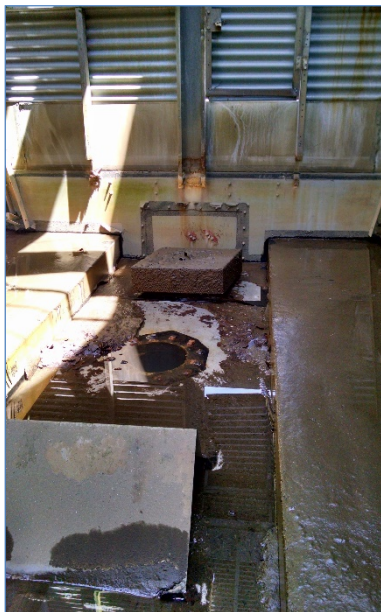
Before

The UMass Memorial Medical Center had a well-used 3000 series Baltimore Aircoil Cooling Tower on the roof. The basin was extremely dirty with a thick deposit of muck and it was leaking. Rust was rampant on the discharge pipe and visible elsewhere.

The HVAC Armor team removed mud and silt from the tower basin, patched and repaired corroded areas, sealed seams with flexible poly-urethane, prepped surfaces and covered the basin with an HVAC Armor coating.

We also cleaned and repaired the cooling tower (fill, tower sills, nozzles, cracked PVC jacketed insulation, and the hot water deck). The walls, louvers, and structural steel were cleaned and sandblasted.
